**ROTARY OPERATOR
PERFORMANCE TEST REPORT**

ACME WINDOW AND DOOR HARDWARE

SERIES: Face-Mount Single Arm - SST

Report No.: D6113.01-106-31

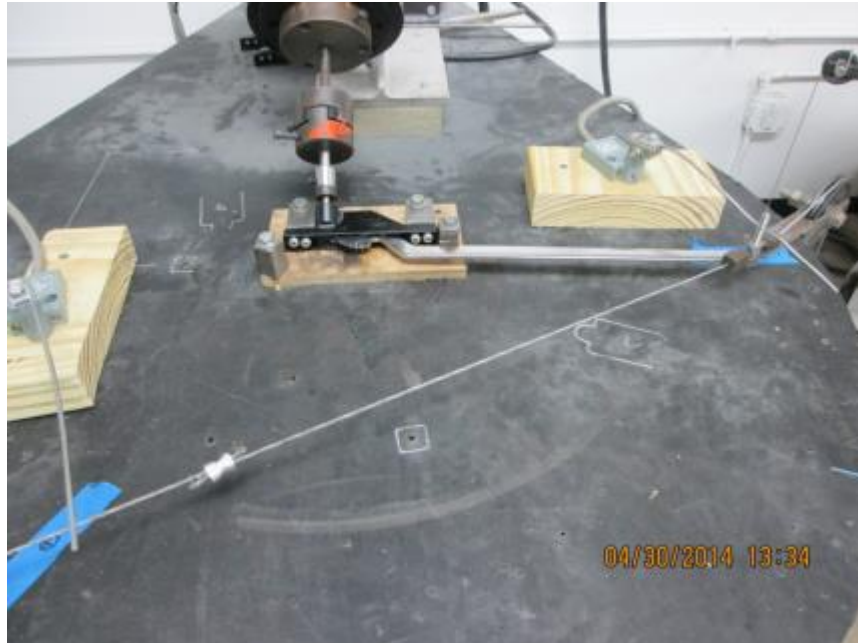
Photo No. 1
Face - Mount Single Arm - SST - Closed Position

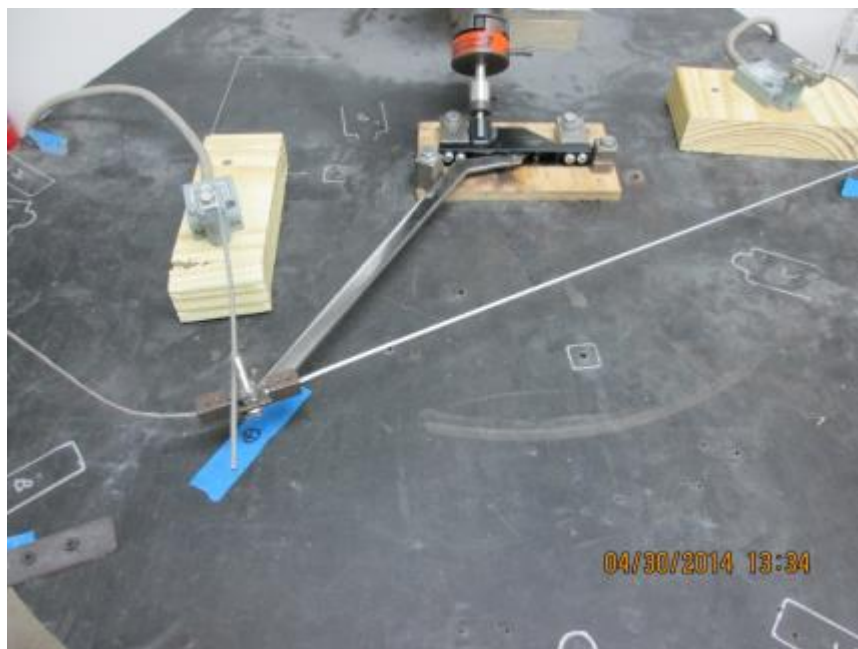
Photo No. 2
Face - Mount Single Arm - SST - Open Position

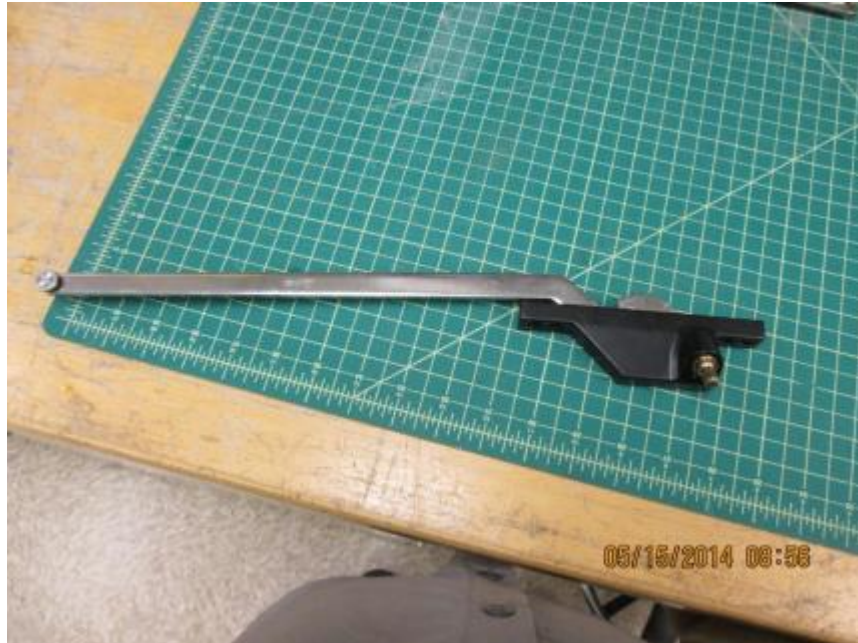
Photo No. 3
Face - Mount Single Arm - SST - Before 300 Hour Salt Spray

Upon completion of 300 hours of exposure to ASTM B 117 conditions, the specimen visual evaluations are as follows:

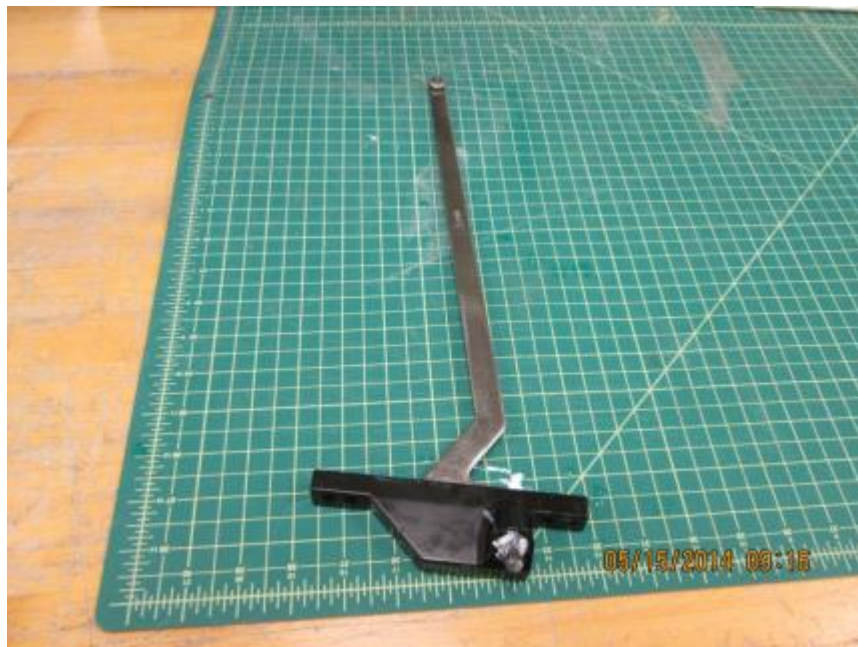
Photo No. 4
Face - Mount Single Arm - SST - After 300 Hour Salt Spray

Face - Mount Single Arm - SST	
Specimen No.	Results
1	Pass - No visible corrosion on operator or any attached pieces
2	Pass - No visible corrosion on operator or any attached pieces
